ASSESSMENT AND PRESERVATION PLAN  
FOR GLENWOOD CEMETERY,  
THOMASTON, GEORGIA

Prepared By:  
Michael Trinkley, Ph.D.  
and  
Debi Hacker

May 22, 2001

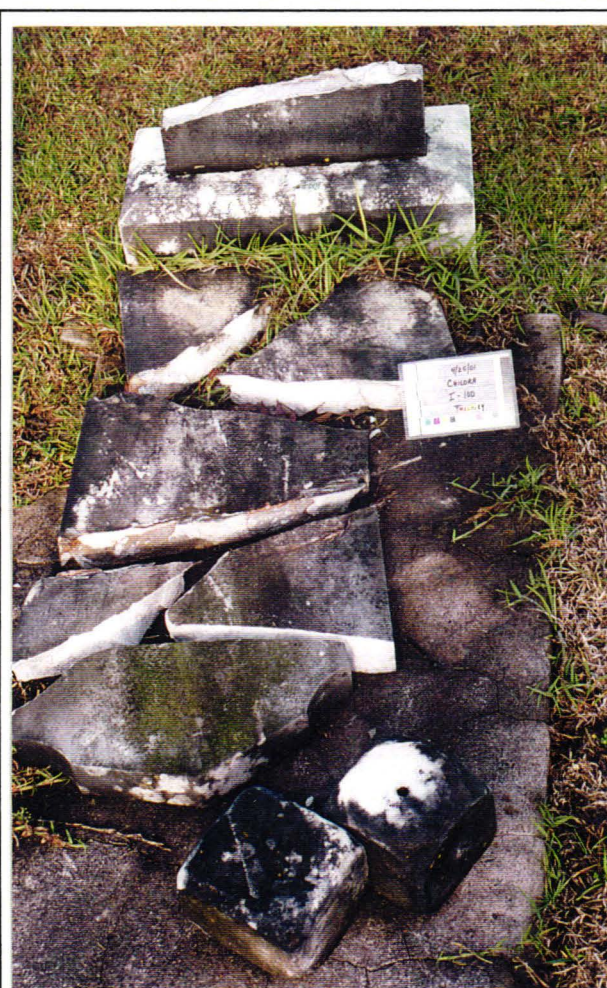
Figure 4. View of recently toppled marker (I-100) which failed along an old repair. When the marker hit the concrete ledger it shattered. Leaving this marker exposed will only compound the damage and encourage theft.

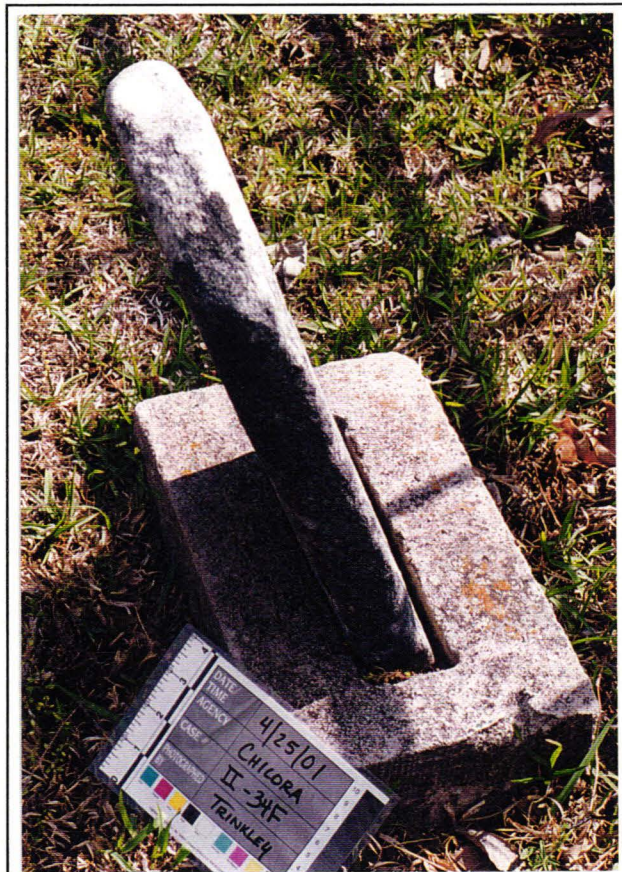
Figure 5. Example of a stone (II-34F) in critical need of resetting. The loose tab and tilting pose a significant breakage hazard to the stone. It is far less expensive to reset such stones than to repair them once broken.

- We have identified 215 stones that require resetting. Most represent monuments with one or more sections loose. With appropriate training, volunteers can repair these problems using a suitable mortar mix. Other stones included in this category are seriously tilted and require excavation and resetting in an upright position. Again, with minimal training volunteers should be able to conduct this work. There are also a number of deteriorated cradle graves which have sunken below grade and require excavation, the creation of a new foundation, and in some cases repair. Some, although not all, of these may be dealt with by trained volunteers.

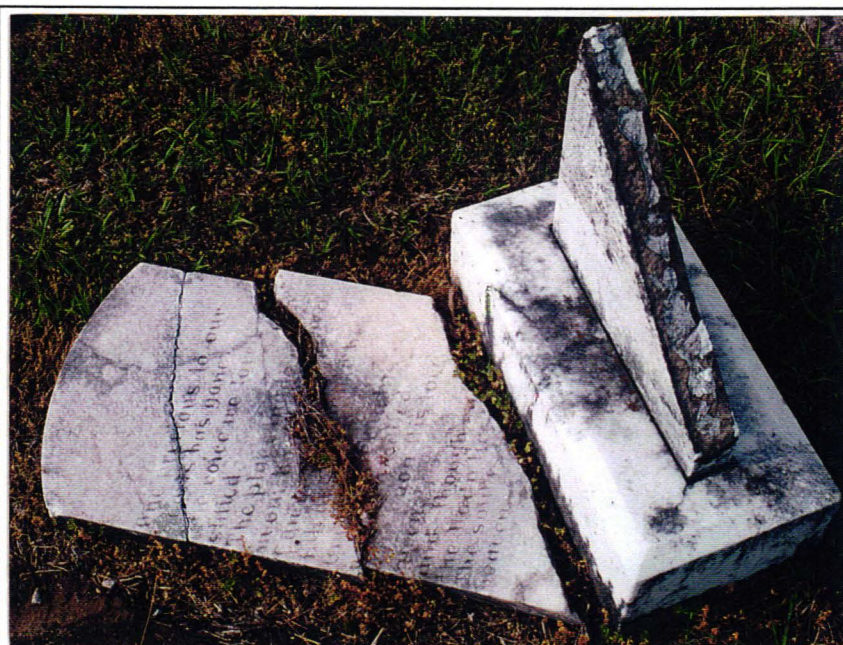
Figure 6. Example of a failed old repair which has resulted in additional damage. Note the continuous bead of adhesive on the exposed old break and also the fragments of new stone that were torn off because the adhesive was stronger than the stone itself. Repair will involve removing the old adhesive and pinning each break.

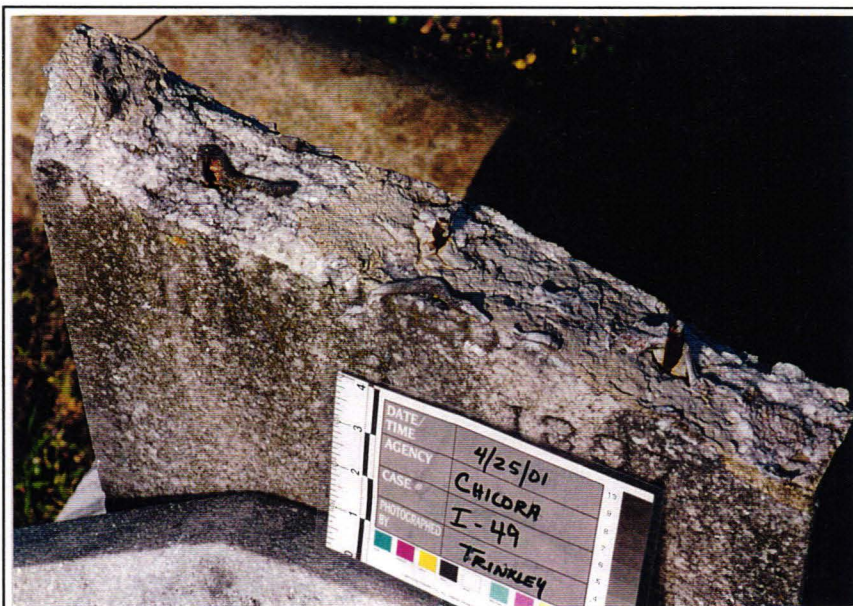
Figure 7. Example of a failed old repair (I-49) which used iron rods. These rods are now corroding and will need to be removed before any repair can be accomplished. The old rods were also far too short to offer any effective support. Note the still intact beads of adhesive — indicating that the stone pieces did not even make contact in these areas.

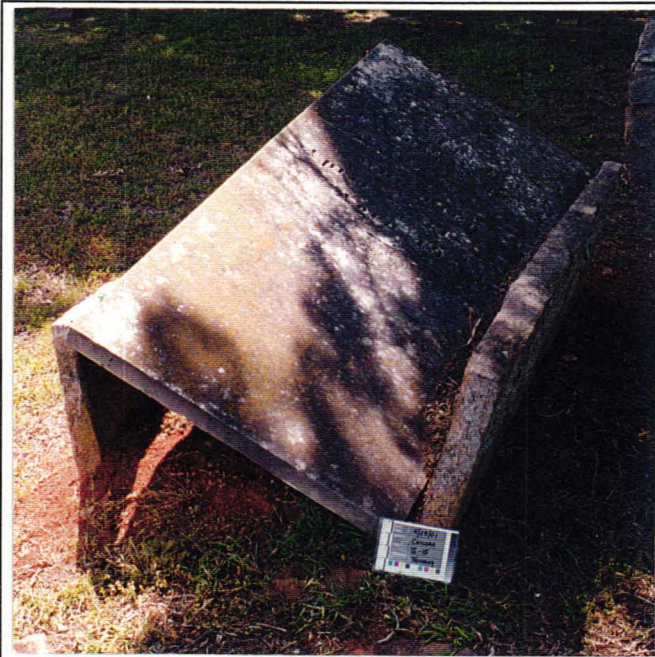
Figure 8. Example of collapsed box tomb (II-15). Repair will require lifting of the marble ledger, reassembly of the granite box, and replacement with leveling of the marble ledger. This is an example of a critical treatment; failure to act will result in the breakage of the marble ledge, leading to a far more expensive repair.

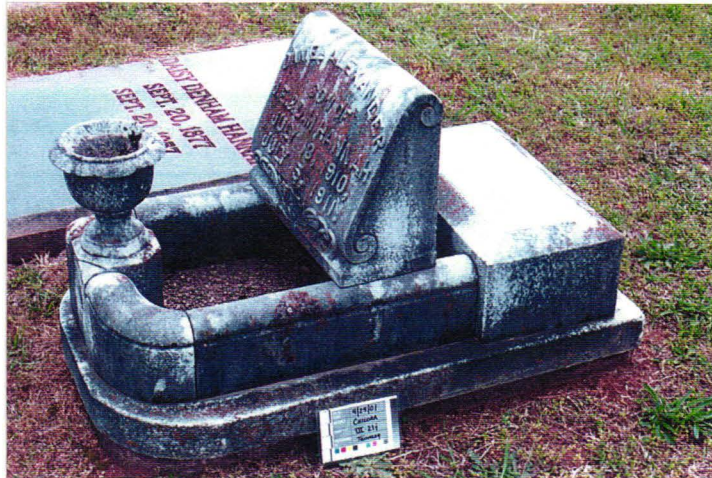
Figure 9. Example of a cradle grave with a displaced plaque marker (III-21J), now resting on the cradles. This stone requires resetting before the cradles are damaged.

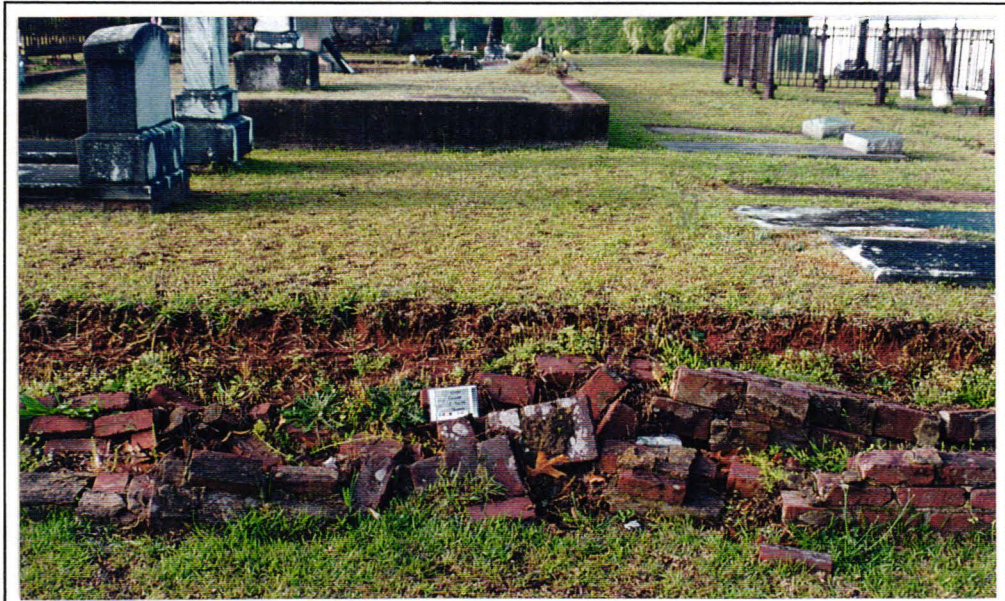
Figure 10. Example of a plot wall (I-55) which has failed. Repair is necessary to prevent the plot from eroding downslope. The work should use as many of the original bricks as possible.

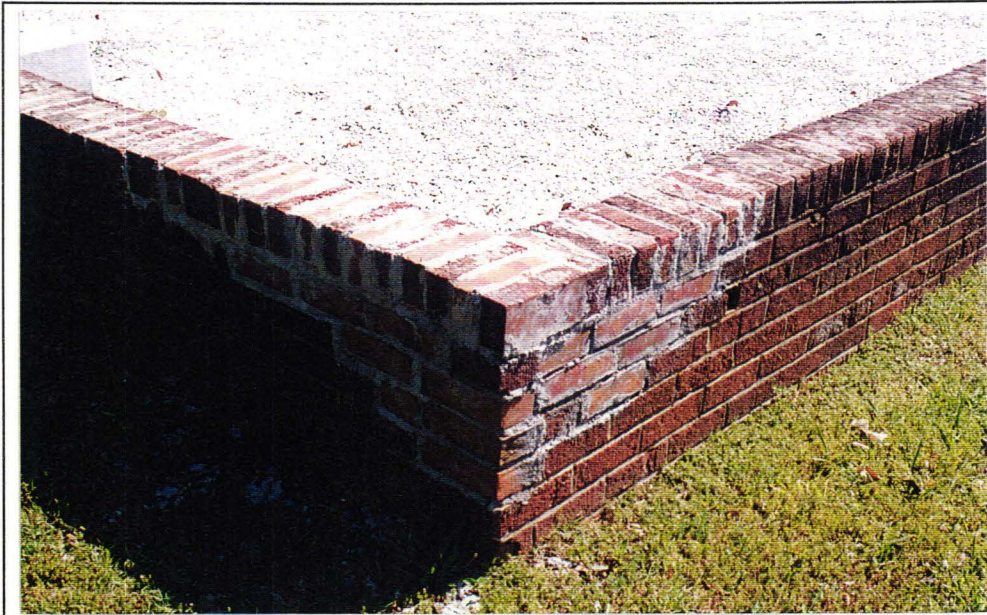
Figure 11. Example of a poorly repaired plot wall. Replacement bricks fail to match either the color or texture of the original work. The mortar joints are uneven and have not been tooled. The mortar itself is the wrong color and fails to match the older material. The poor workmanship is also revealed by the failure to clean off the bricks.

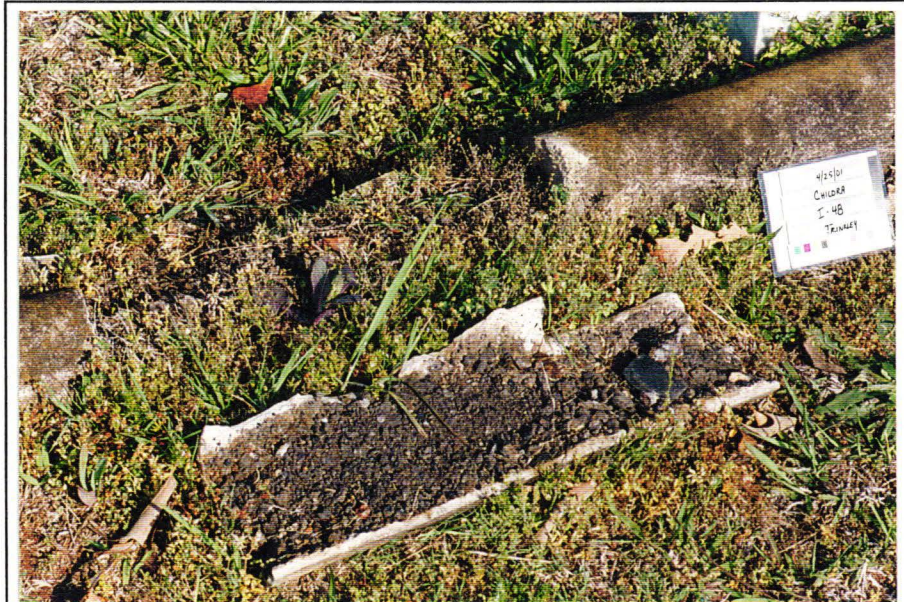
Figure 12. Example of failed concrete coping (I-48). Large sections are spalling off, probably because the mix used clinkers (note the large specimen in the spalled section).

- We identified 60 copings in dire need of repair or, in some cases, replacement. Many of the old concrete copings were laid using a mix containing large quantities of clinkers. Because of the sulfate in the clinkers, the damage to these copings is so serious that repair is not possible. They need to be removed

and replaced with similar cast coping. This work can most cost-effectively be accomplished by a firm specializing in concrete forming and finishing, under the supervision of a conservator. Other copings, however, have simply been displaced or damaged. Many of these can be repaired by volunteers, again with appropriate training and supervision.

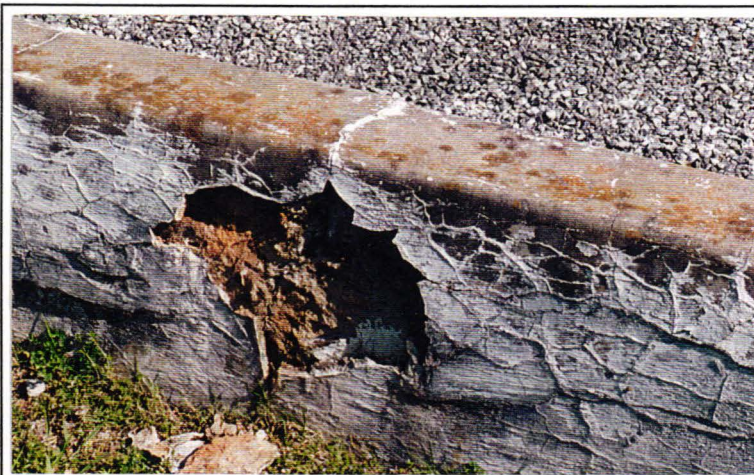
Figure 13. Spalling concrete coping which has been previously whitewashed. Here the spalling is likely the result of an inappropriate mix or excessive floating of fines to the surface.

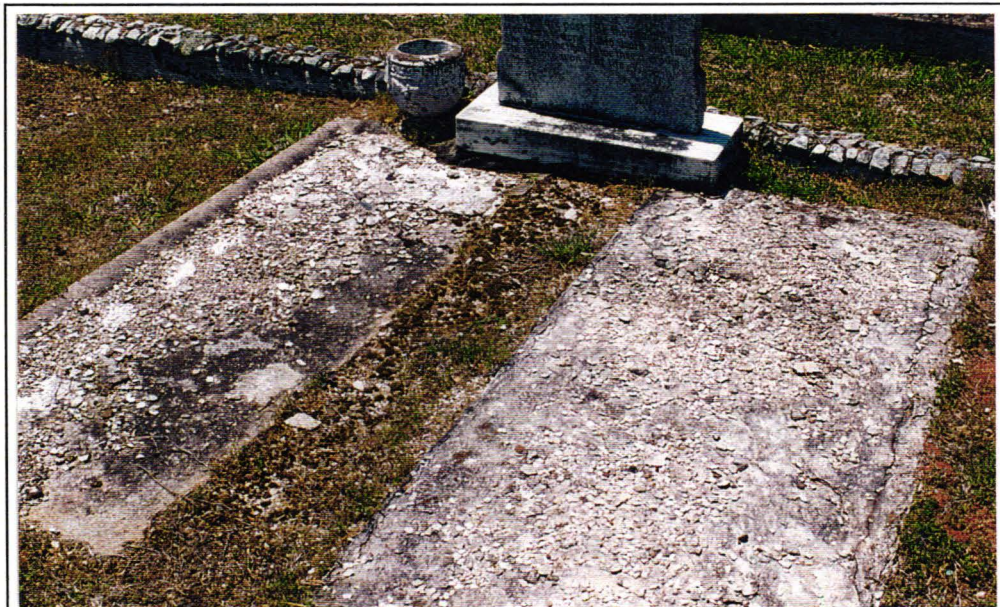
Figure 14. Example of scaling concrete ledgers at Glenwood. Here the damage is probably associated with excessive moisture penetrating the surface layer and freezing during the winter.

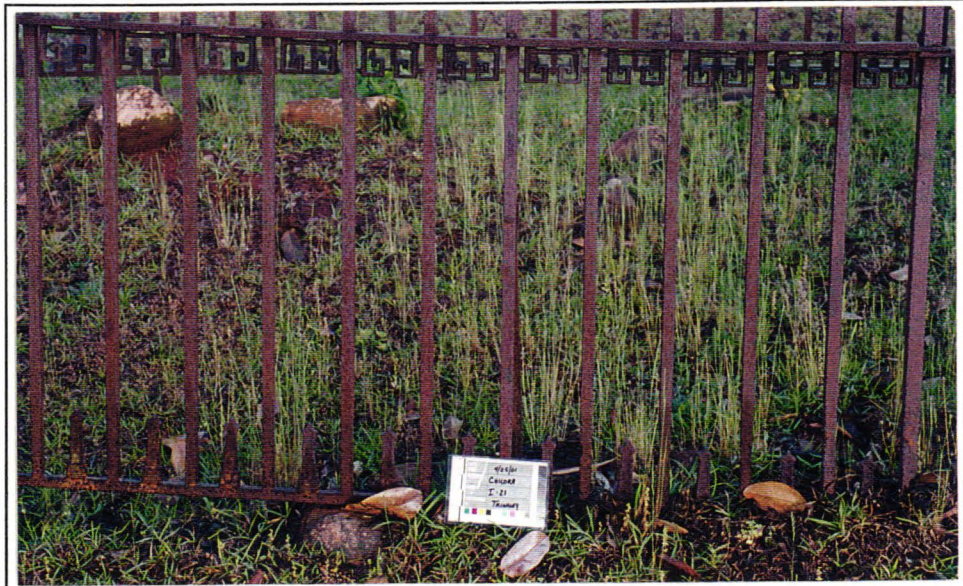
Figure 15. Iron fence (I-21) with bottom rail partially buried below grade. Constant exposure to soil moisture hastens corrosion. The solution is simple — uncover the buried ironwork and ensure that the fence is appropriately prepared and painted.

- The fences require multiple repairs, including reattaching loose sections, excavation to remove bases from accumulated soil, and rehanging various gates. A wire bedstead requires immediate attention, including efforts to straighten and, if necessary, reinforce using stainless steel supports.

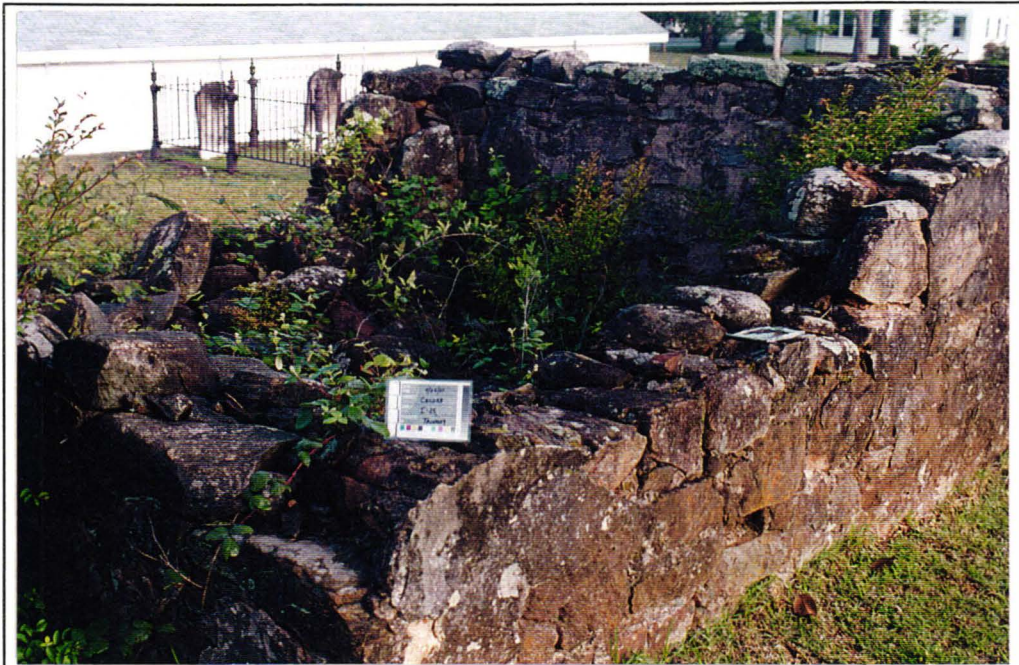
Figure 16. Rock wall (I-25) showing extensive failure and collapse of the upper walls. Repair should be given a high priority since this feature poses a hazard to the public.

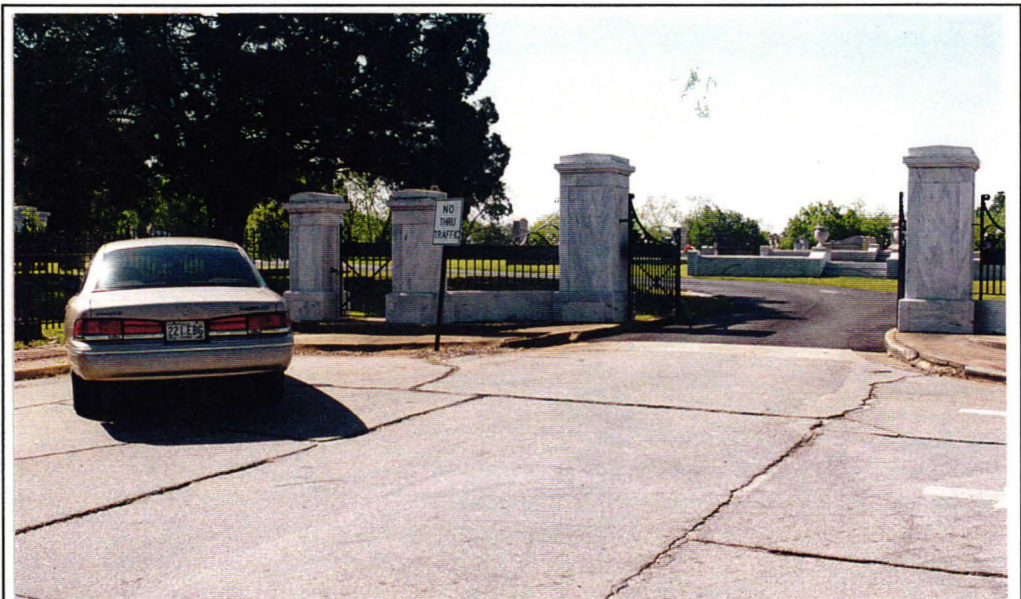
Figure 17. Main entrance to Glenwood off South Hightower. Note the poor condition of the roadway, the car parked at the yellow curb, the distant "No Thru Traffic" sign, and lack of any regulatory signs for the cemetery.

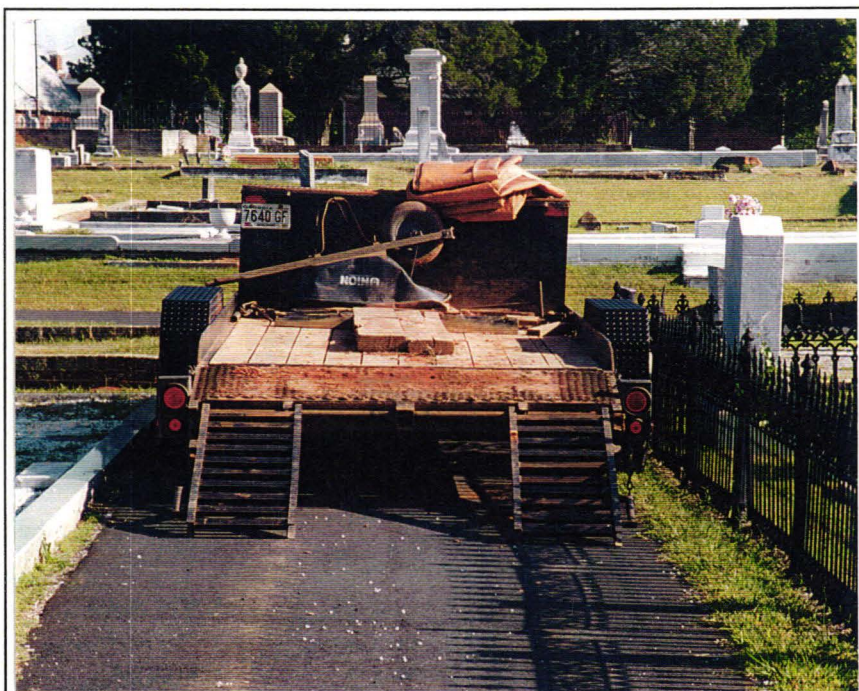
Figure 18. Example of construction trailer on north-south road off Mallory, with only inches of clearance on either side. To the right is plot V-4, which has been previously damaged by a vehicle.

- Given the narrow roads and evidence of abundant and frequent damage to stones and coping, we recommend that construction trailers or any equipment larger than a full-sized automobile be prohibited from entry into the cemetery. Such vehicles should off-load equipment and/or materials for transport by smaller equipment into the cemetery. While some may complain of higher labor costs, this is preferable to the extent and nature of damage which is apparent in the cemetery.

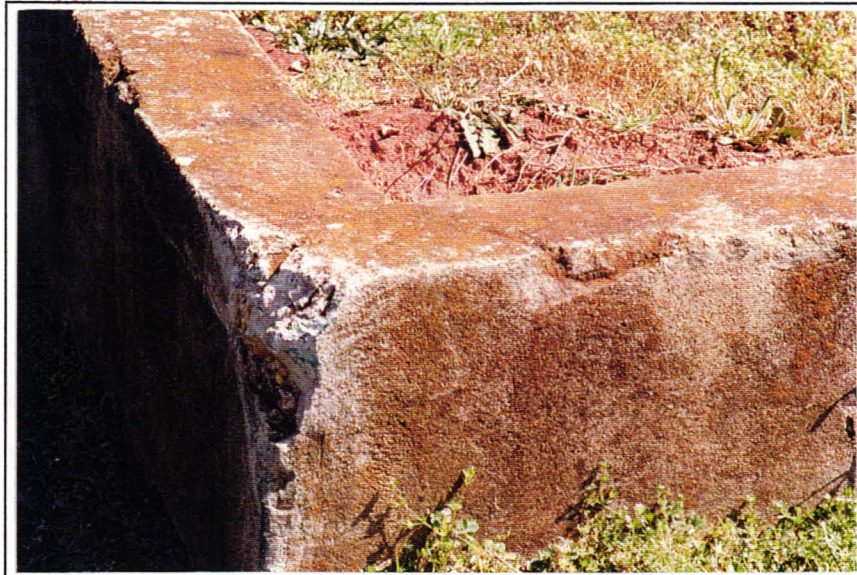
Figure 19. Example of concrete coping with extensive damage from repeated vehicular impacts.

- We also recommend that bollards be installed at all corners and adjacent to fences in order to protect plots from additional vehicular damage.

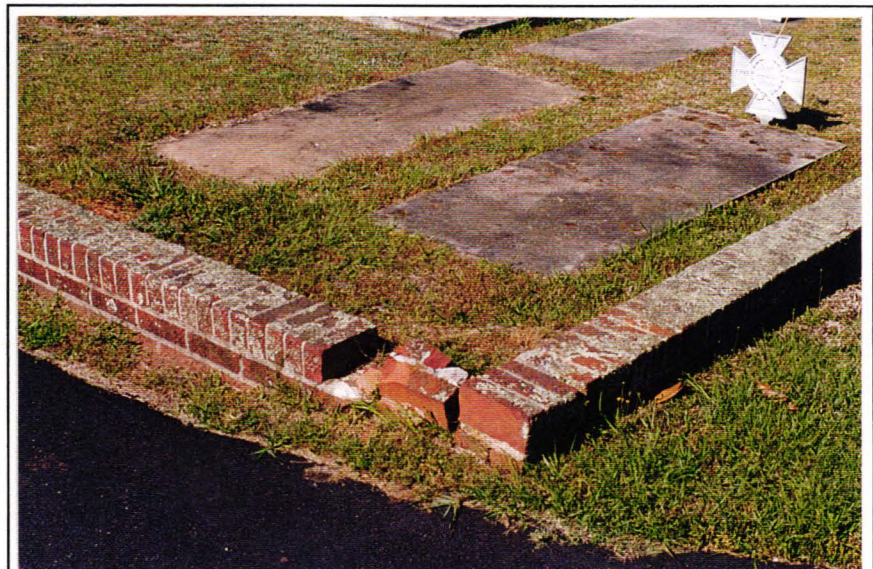
Figure 20. Example of brick coping damaged by vehicular impact.

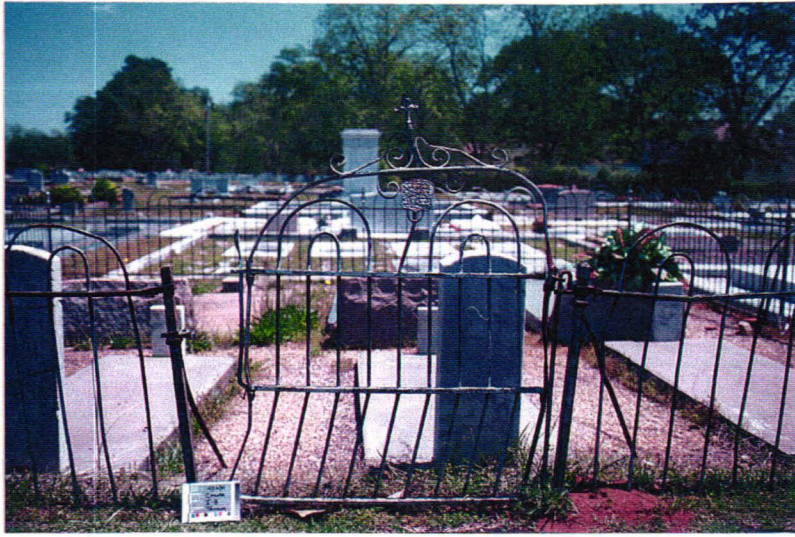
Figure 21. Example of a gate (V-8) twisted and damaged by a vehicle.

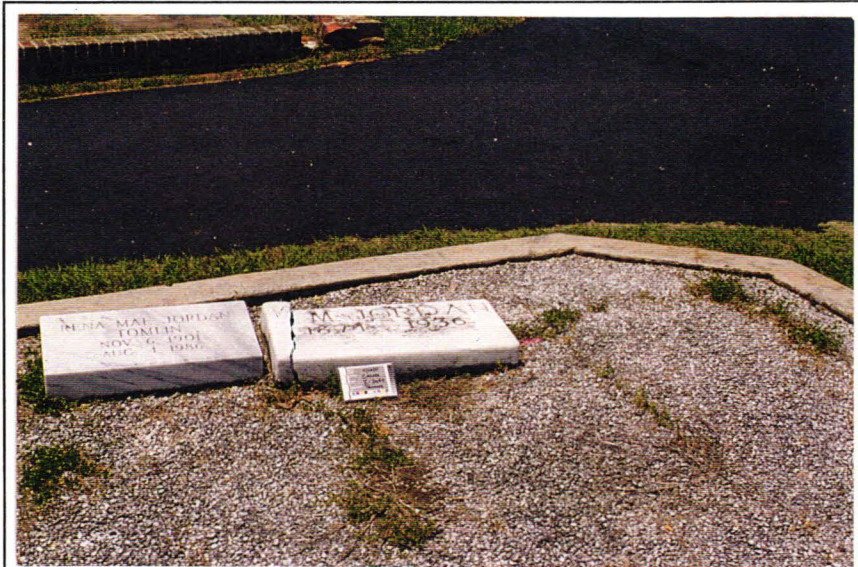
Figure 22. Marble lawn type markers (V-3G and H) shifted out of position by a vehicle making a sharp turn. One marker has also been broken.

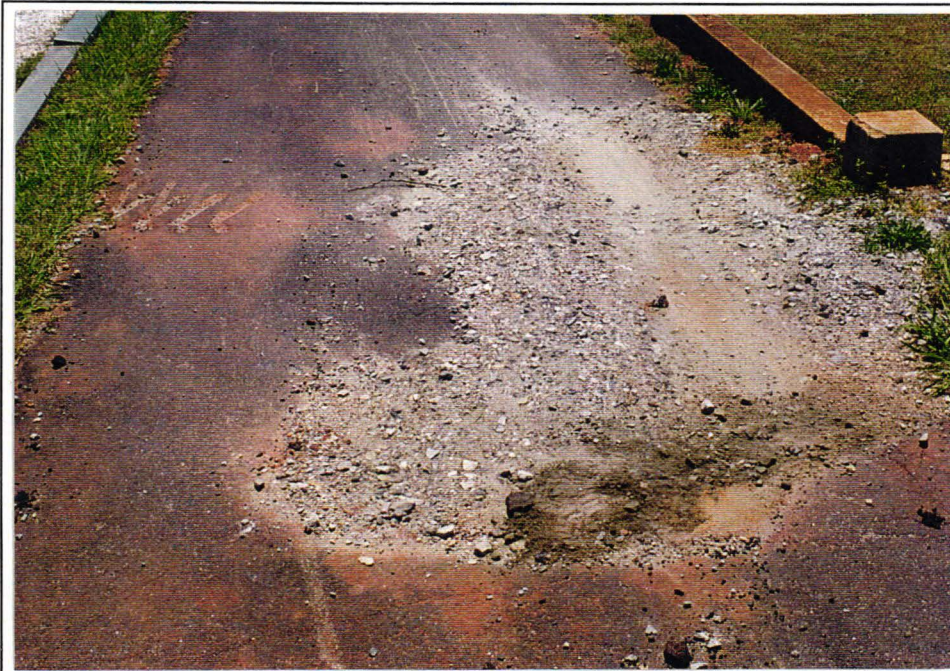
Figure 23. Section of the Glenwood Cemetery road which is already in failure and which has been "patched" used loose crush-run gravel. Notice to the side imprint of heavy equipment.

- The City should consult with a civil engineer to determine the cause of

the seemingly rapid deterioration of the recently repaved roads and the steps necessary to either restore the current roads or replace them with some more durable material.

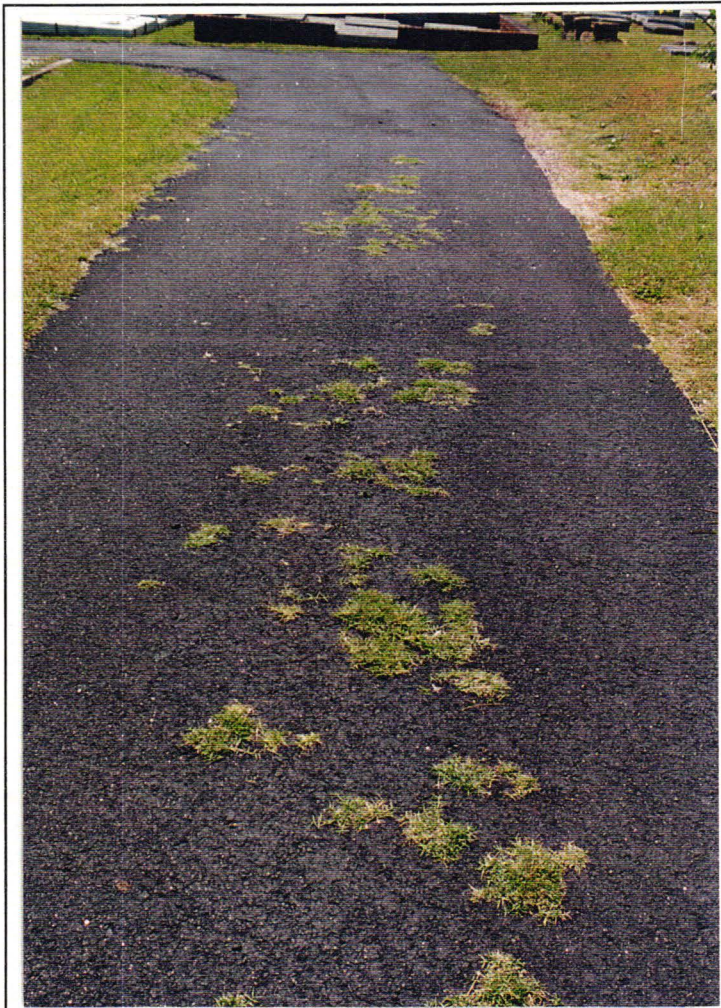
Figure 24. Grass breaking through recently repaved roads at Glenwood Cemetery.

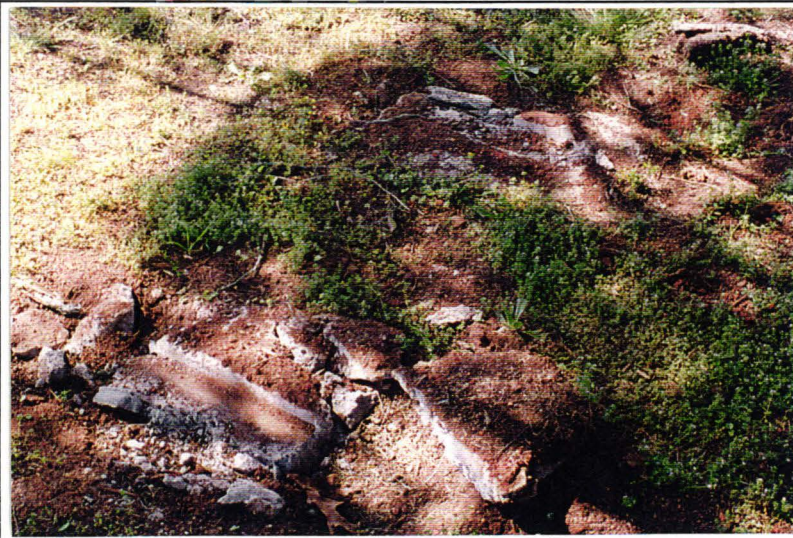
Figure 25. Concrete debris and torn up grass in the previous bench location.

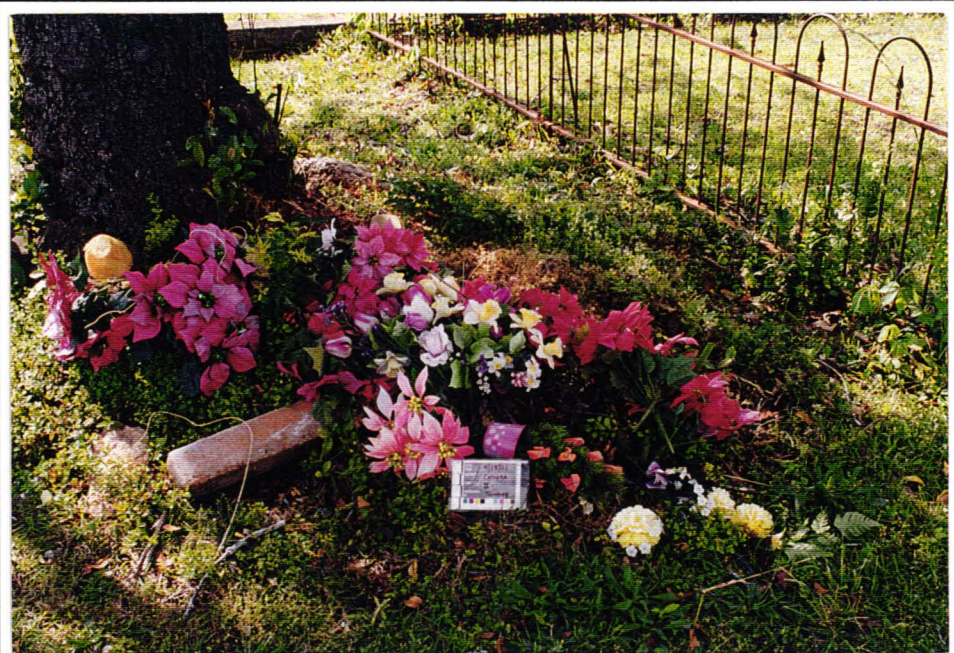
Figure 26. Dump area for old flowers and floral debris south of plot II-78.

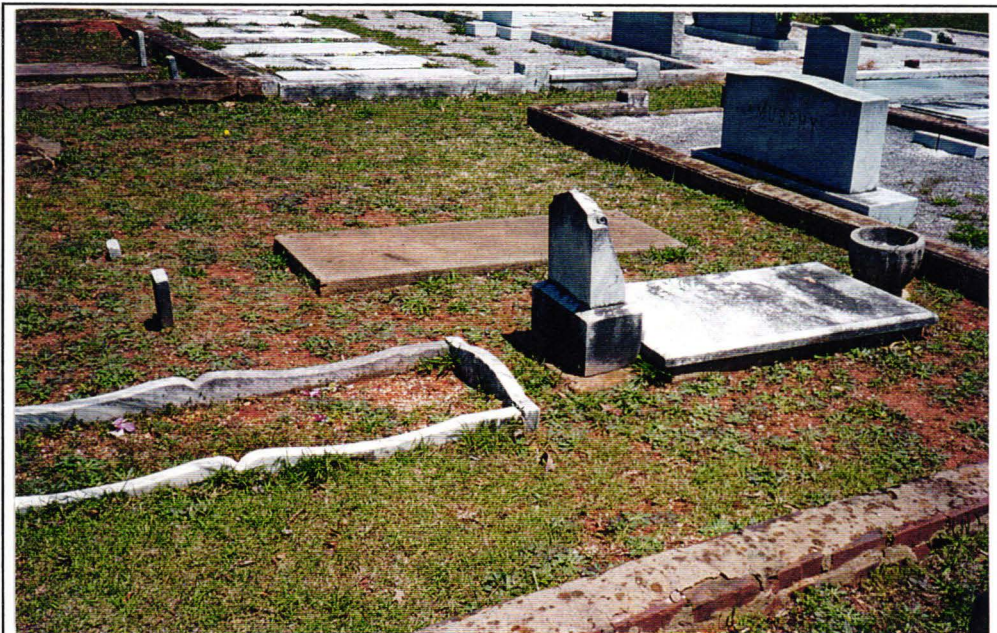
Figure 27. Area of thin, poorly developed grass.

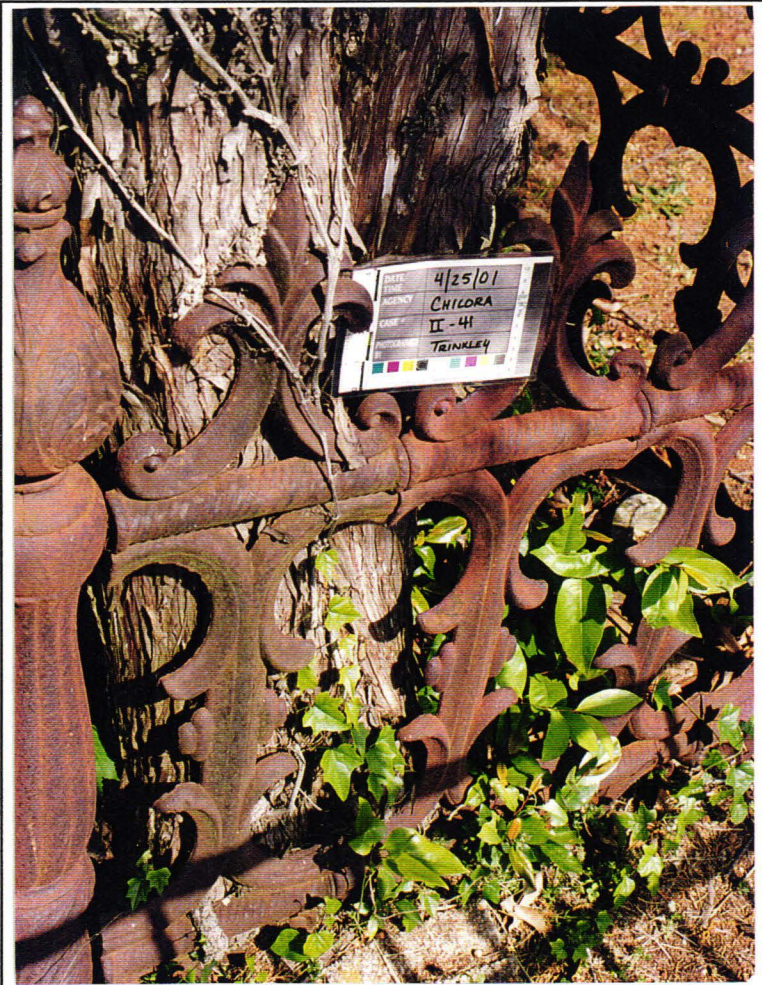
Figure 28. Cedar which is beginning to grow into the fence on plot II-41.

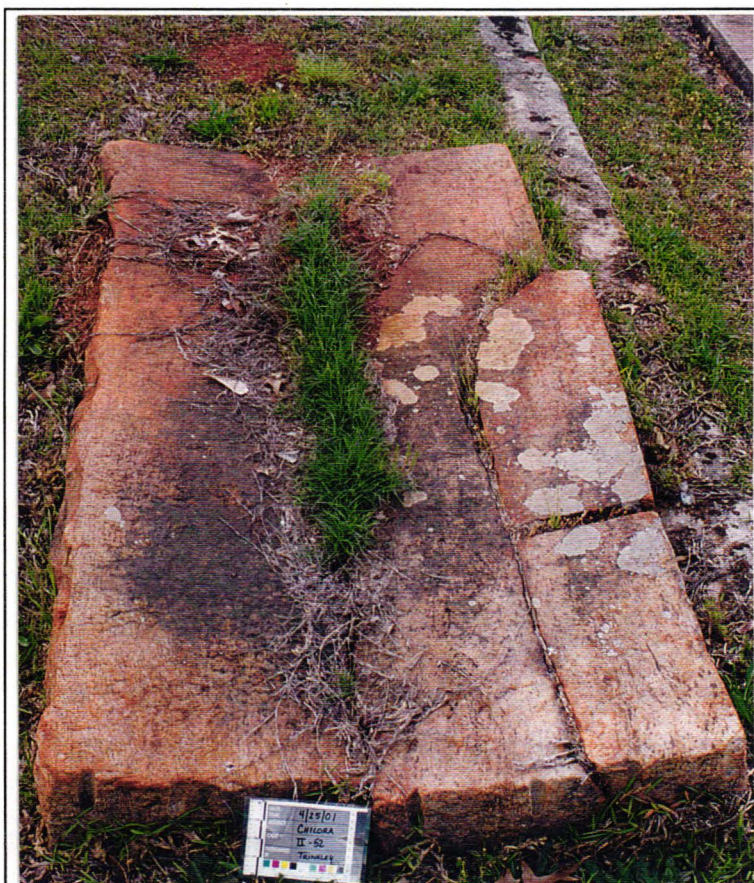
Figure 29. Example of grass growing between breaks in a ledger. Rather than using a trimmer to “cut back” the grass, the stone needs to be repaired and reset, preventing grass from taking hold in the open cracks.

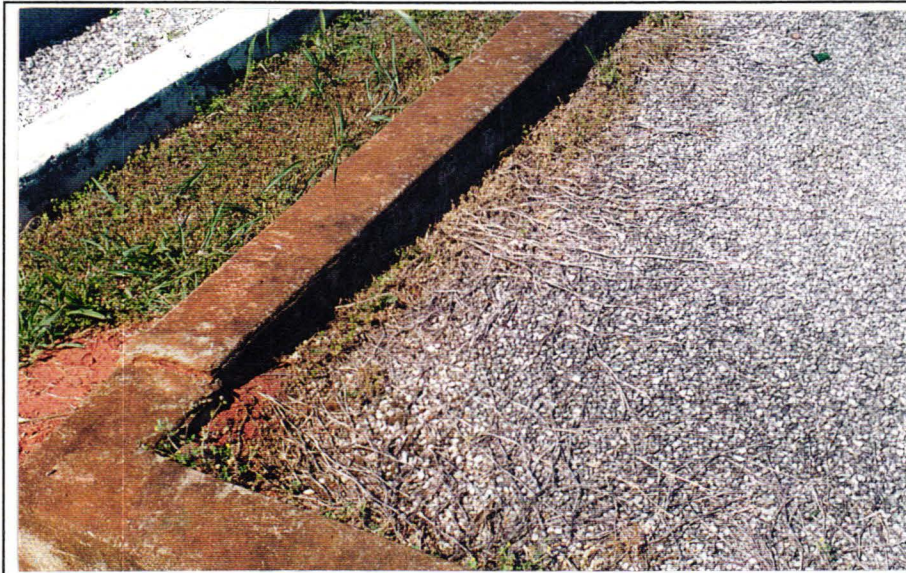
Figure 30. Example of grass killed with an herbicide in a plot. While dead, the grass is still an aesthetic problem and needs to be manually removed.

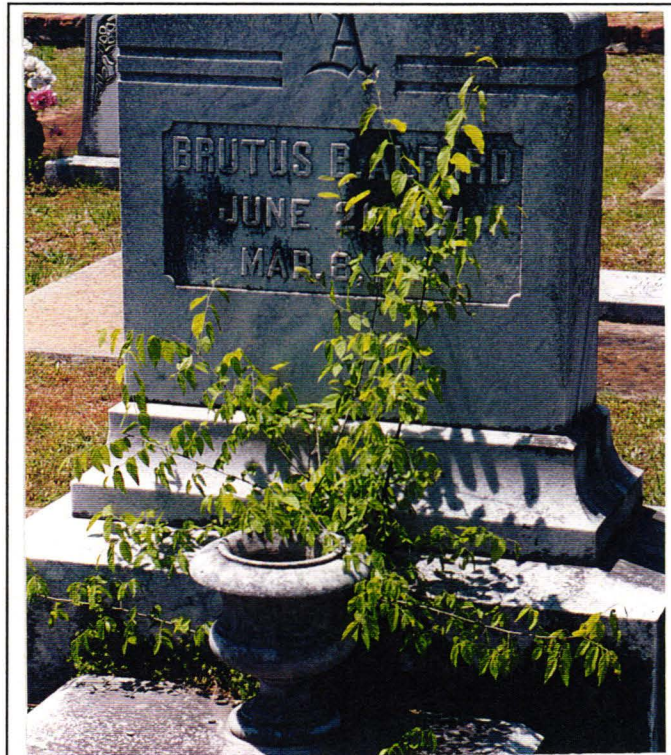
Figure 31. Scrub tree between ledger and die on base which needs to be cut and then brushed with a woody brush herbicide to prevent suckers from returning.

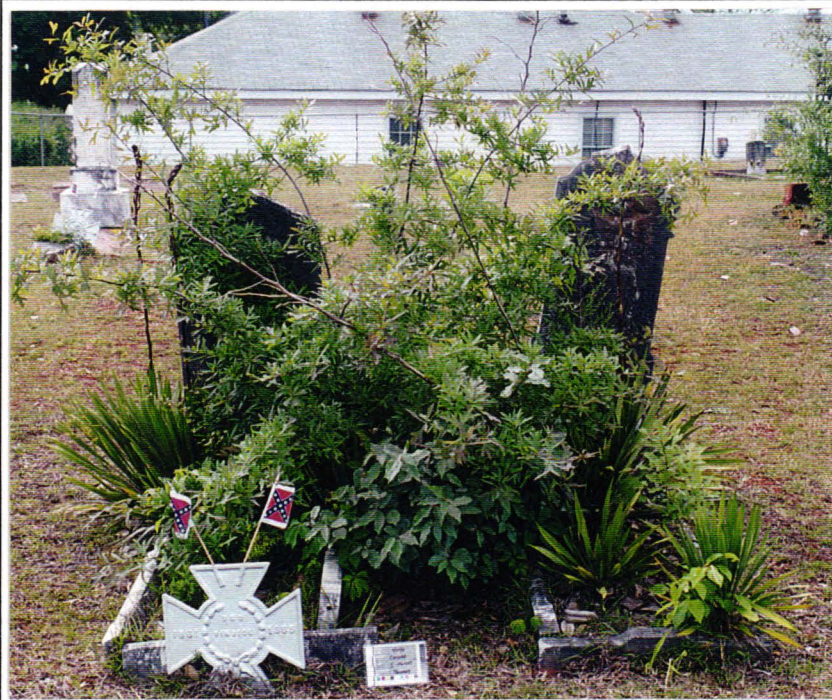
Figure 32. Graves I-146 & 147 in an overgrown and abandoned condition.

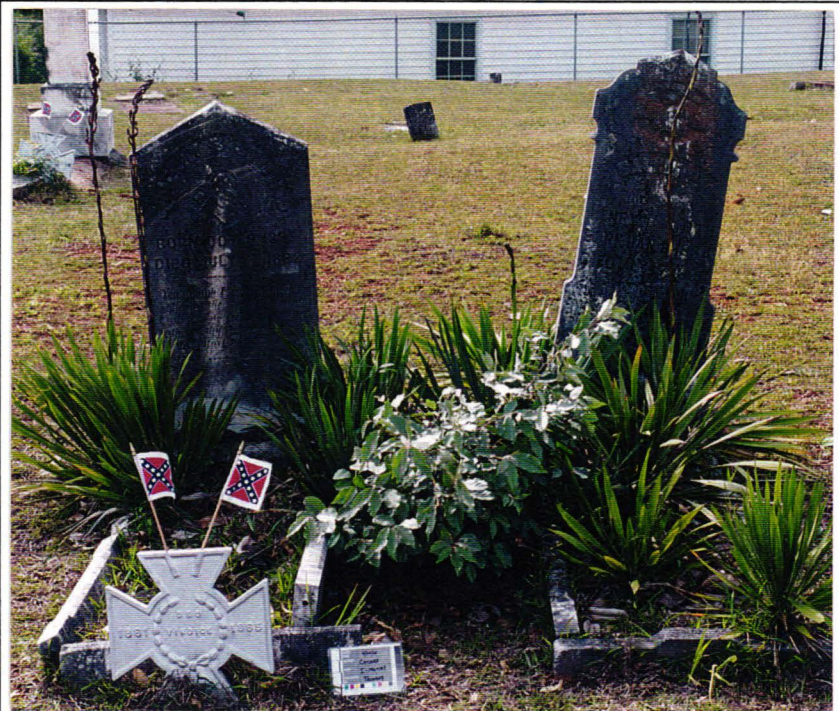
Figure 33. Graves I-146 & 147 after only 0.25 person hour of work. After cutting out scrub vegetation the stems should be painted with a brush herbicide to prevent suckers from returning. The original plantings should always be carefully protected.

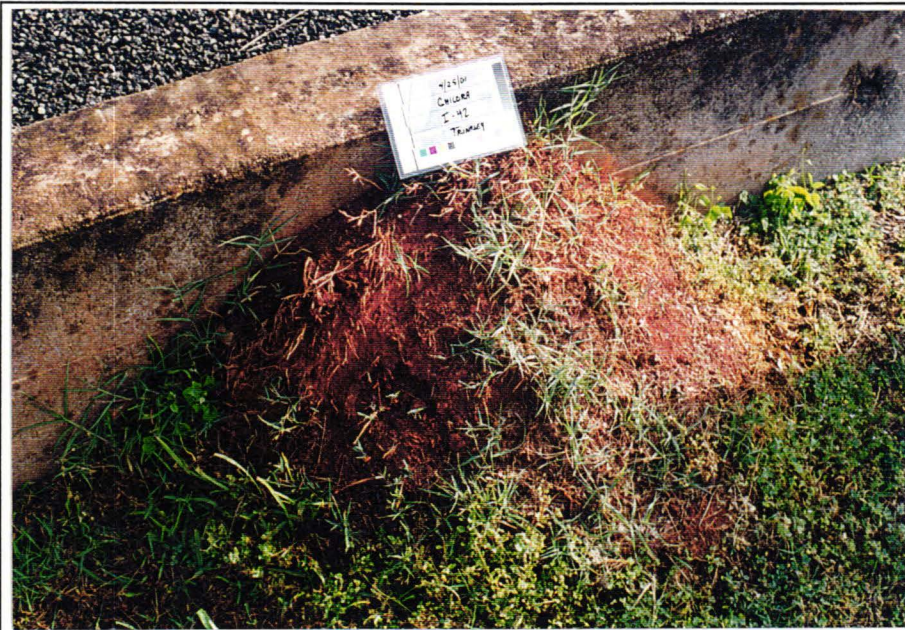
Figure 34. Fire ant mound on the exterior of coping (I-42). Recommended treatment combines a bait such as Amdro, followed in about 6 months by a dursban drench.

- Fire ants are not controlled at Glenwood and this presents a significant liability to the City. We recommend that Amdro™ be used on identifiable mounds between April 15 and October 15, with a six-month follow-up treatment of a dursban drench. Once a mound is eradicated, the built-up soil should be removed and the sod releveled.

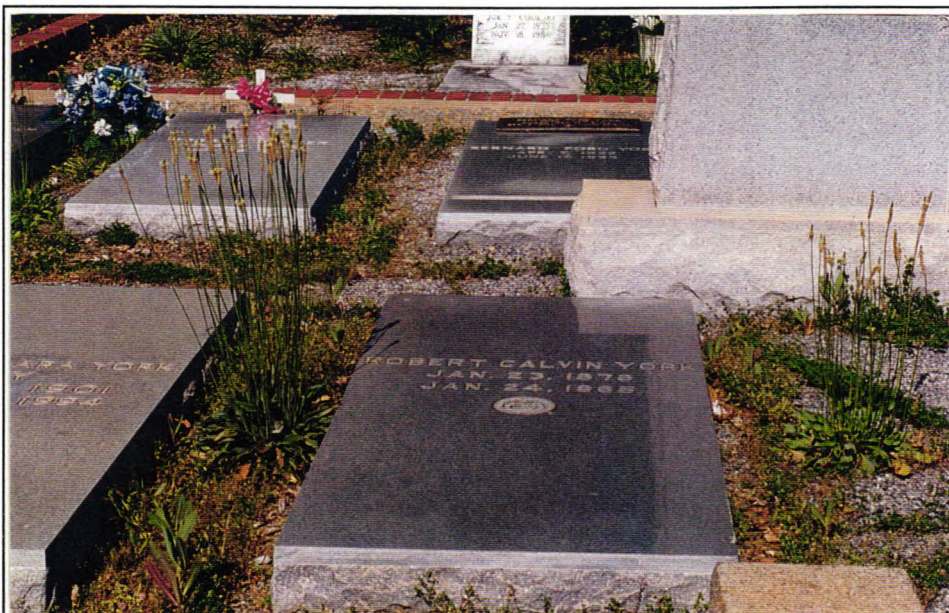
Figure 35. Example of abundant, tall weeds in a gravel plot. Some have already gone to seed, spreading the problem to other plots.

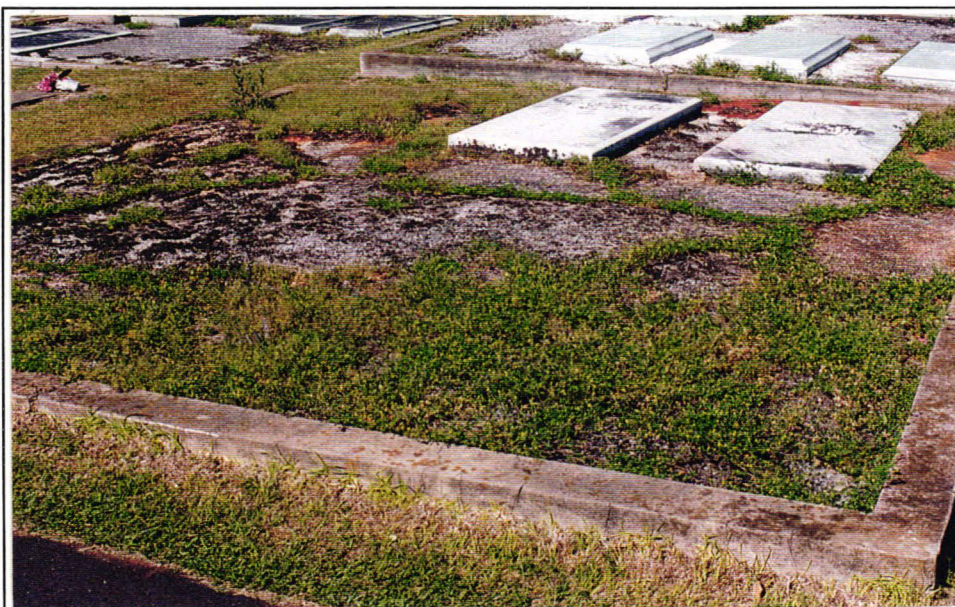
Figure 36. The weeds in this plot have become so dense that it is difficult to see the original gravel. In such cases extensive rehabilitation of the plots is necessary. The weeds must be killed and removed, then a weed barrier needs to be installed, followed by additional gravel.

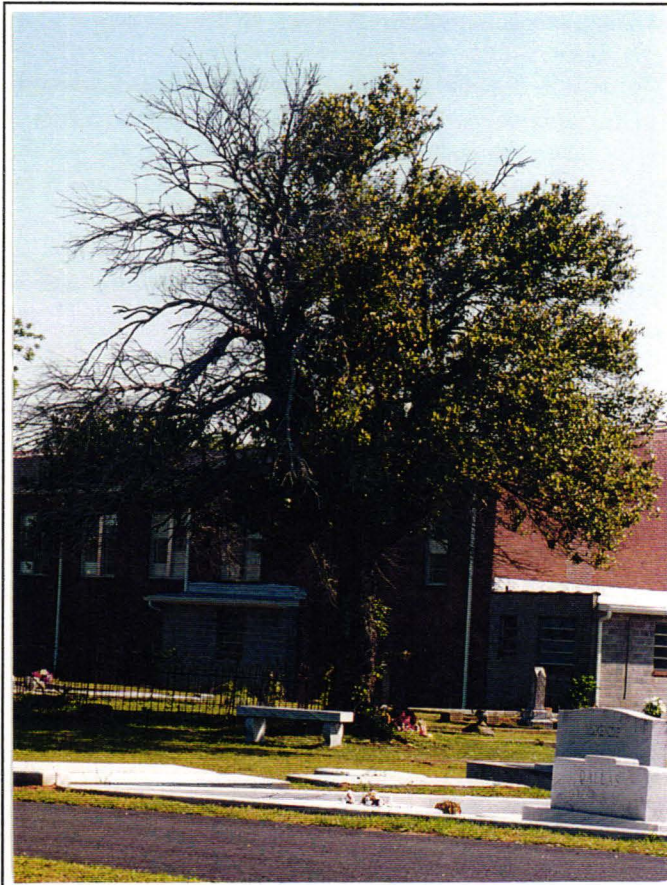
Figure 38. Example of a tree at Glenwood with much deadwood which has never been properly pruned out. This tree requires immediate professional attention.

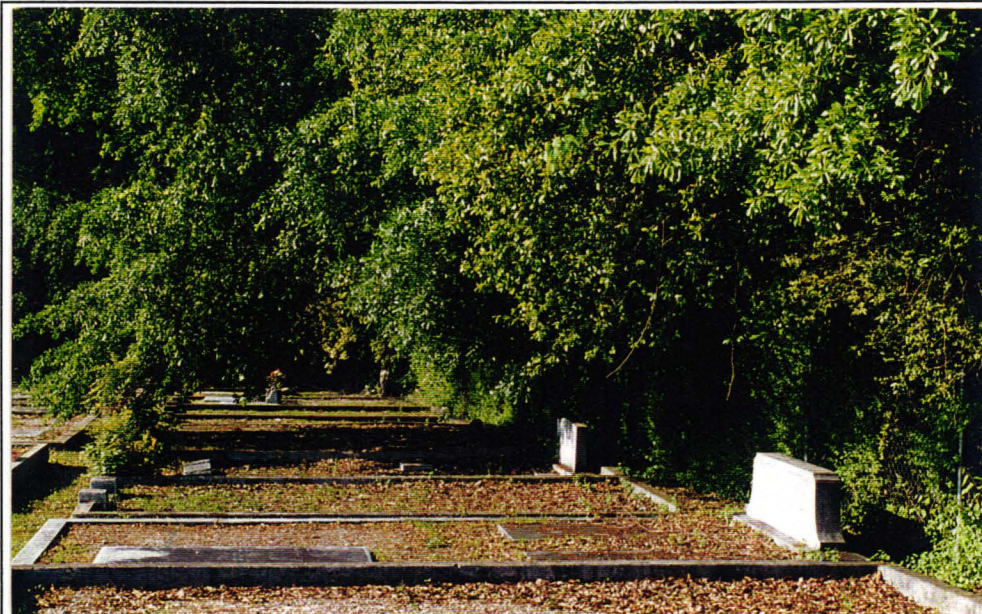
Figure 40. Abundant overhanging trees and vegetation along the fence line. These areas, which exhibit no previous landscaping efforts, need to be cleaned up immediately.

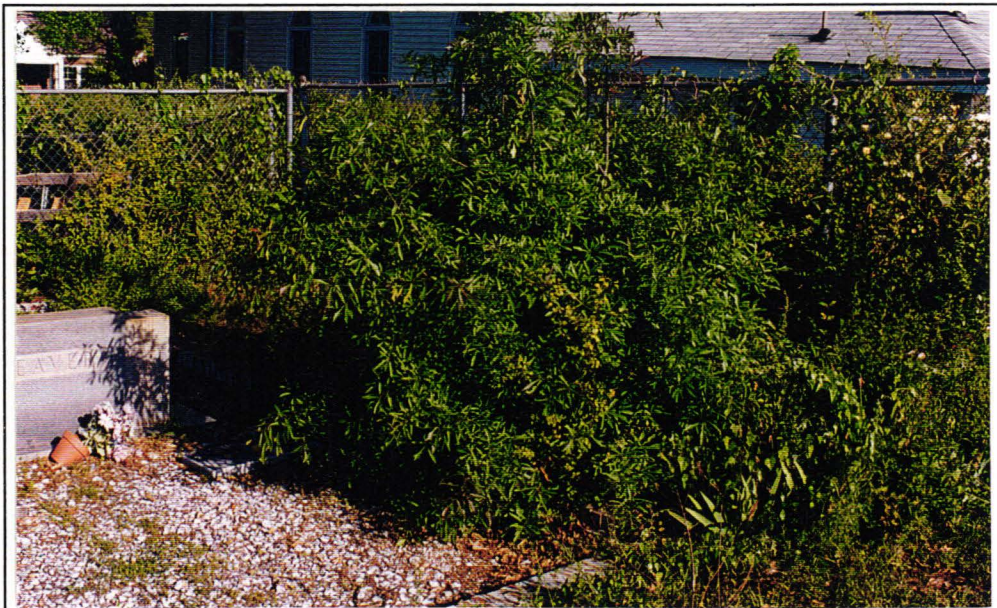
Figure 41. Thick undergrowth, often containing poison oak and other noxious weeds, along the cemetery fence lines. These require immediately manual removal, with herbicide applied to the stems for long-term control.
